3D TRASAR™ Technology for Crude Overhead Systems Identifies Root Cause of Low pH Events

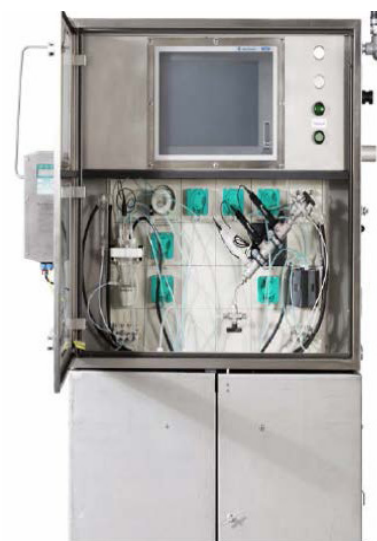
FIGURE 1: 3D TRASAR FOR CRUDE OVERHEAD SYSTEMS EQUIPMENT

Following an incident investigation, Nalco Water's 3D TRASAR technology was implemented and connected to the distributed control system to help the site understand real time behavior of the chloride concentration, pH and iron levels in the overhead system. The 3D TRASAR system was set to send an alert to Nalco Water and customer operations personnel whenever conditions of high corrosion risk occurred.

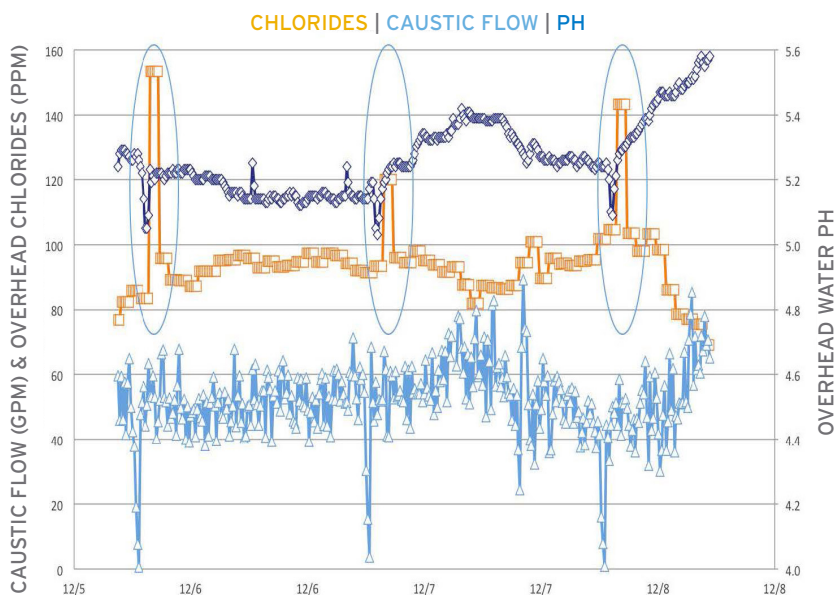
FIGURE 2: 3D TRASAR TECHNOLOGY FOR CRUDE OVERHEAD SYSTEMS

Chloride spikes and pH drops became noticeable when water in the hot accumulator fell, indicating reduced tolerance for process variability. Each evening, the 3D TRASAR system consistently sent an alarm that pH had dropped 0.3 pH units and chloride spiked from 50 PPM to 100+ PPM. Nalco Water and the customer found what appeared to be a short duration upset condition occurring on a train of desalters approximately 30-40 minutes before each pH/Chloride event (Figure 2).

Further investigation showed these events aligned with desalter mud washes where, in addition to short-term pressure fluctuations, caustic flow dropped to 0.0 GPM between 30 to 40 minutes - the same duration as the atmospheric

overhead events identified by the 3D TRASAR Technology for COS (denoted by the blue circles in Figure 2). Caustic flow rate reduction was the result of pump mechanical issues, which stopped caustic flow during short-term pressure fluctuations. A mechanical survey performed on the desalter identified mud wash piping and operational differences between desalter trains as the root cause for the pressure fluctuations.

These differences could not be addressed while the unit ran, so the caustic pump was repaired to ensure caustic injection during mud wash, thereby eliminating the pH/chloride nightly events.

As a consequence of these findings, the mud wash piping arrangement was changed in the next turnaround to eliminate the pressure interference and the overhead condenser bundles were pulled and cleaned in an effort to improve first stage water condensation. Additional mechanical and operational changes were made to minimize corrosion events using the proven 3D TRASAR system.
